VALUE FOR MONEY AUDIT REPORT

UTILISATION OF DAMS, A CASE OF TUGWI-MUKOSI DAM

**MINISTRY OF LANDS, AGRICULTURE, FISHERIES, WATER AND RURAL
DEVELOPMENT**

VFM 2024:02

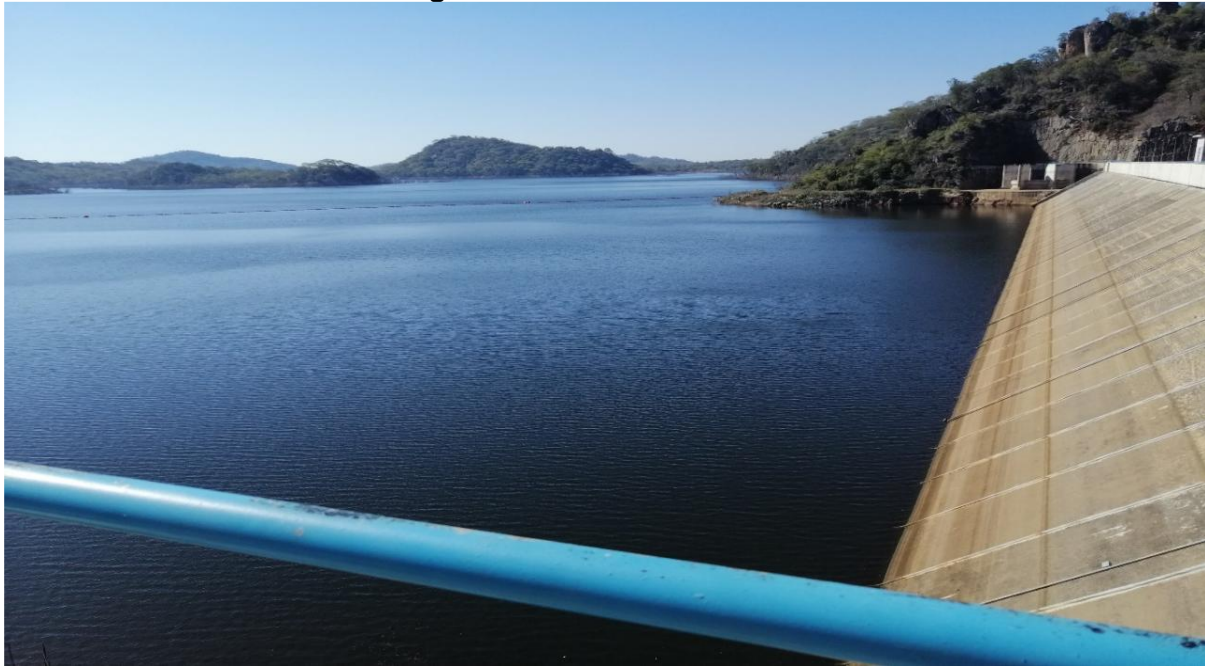
Picture A: Cross Section of Tugwi Mukosi Dam.

Construction of the dam began in June 1998 and eventually completed in December 2016. The dam was commissioned in May 2017. The dam was constructed by a contractor named Salini Impregilo. Tugwi-Mukosi is the largest inland dam in Zimbabwe with a 90-metre height dam wall, a back throw of over 35 kilometres and capacity to hold more than 1.8 billion cubic meters of water. Tugwi-Mukosi has a potential to change the face of the province as there are a number of business opportunities, ranging from tourism, wildlife and farming activities.

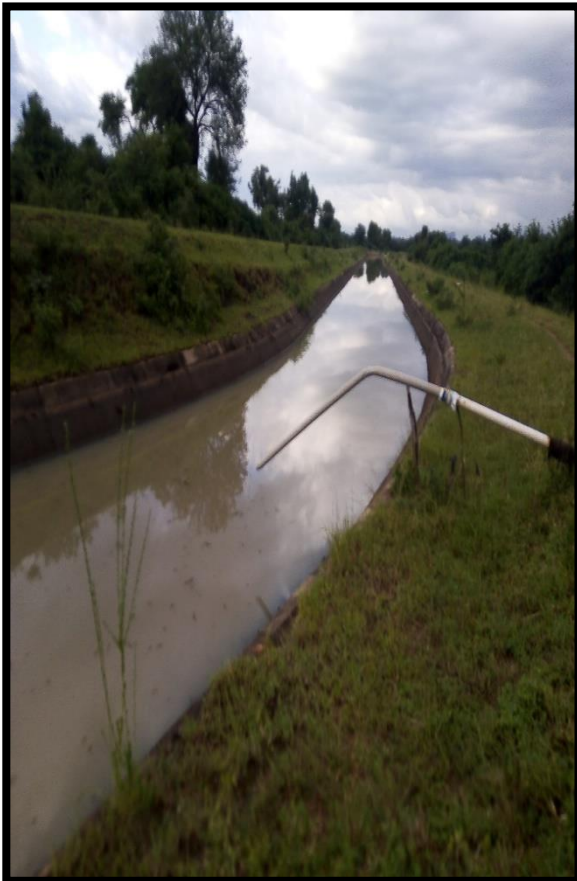
Picture B: Illegal abstraction from canal.

My inspection on a Tokwane Canal conveying water from Tugwi Mukosi Dam also revealed that there were a significant number of farmers who were illegally abstracting water from the canal for commercial agricultural activities. It was revealed that a penalty of US\$20 for illegal abstraction was not deterrent enough as farmers continued abstracting. According to a 2019 report produced by the ZINWA Security Department after conducting an inspection on Mutirikwi Canal, it was noted that most of the illegal abstraction activities were being carried out during the night. **Pictures B & C** below shows pipes used to abstract water from the canal to irrigate crops in the gardens.

Cases of illegal abstractions have been increasing and local leadership together with the office of the Minister of State for Provincial affairs have been notified of this illicit activity but no conclusive solution has been found. ZINWA is carrying out sporadic checks on illegal abstractors. Various pieces of equipment have been confiscated to date but this has not deterred the illegal abstractions. Proposals to regularise these activities were made. The office of the Minister of state for Provincial affairs is expected to work on the regularisation and complete it by end of 2024.

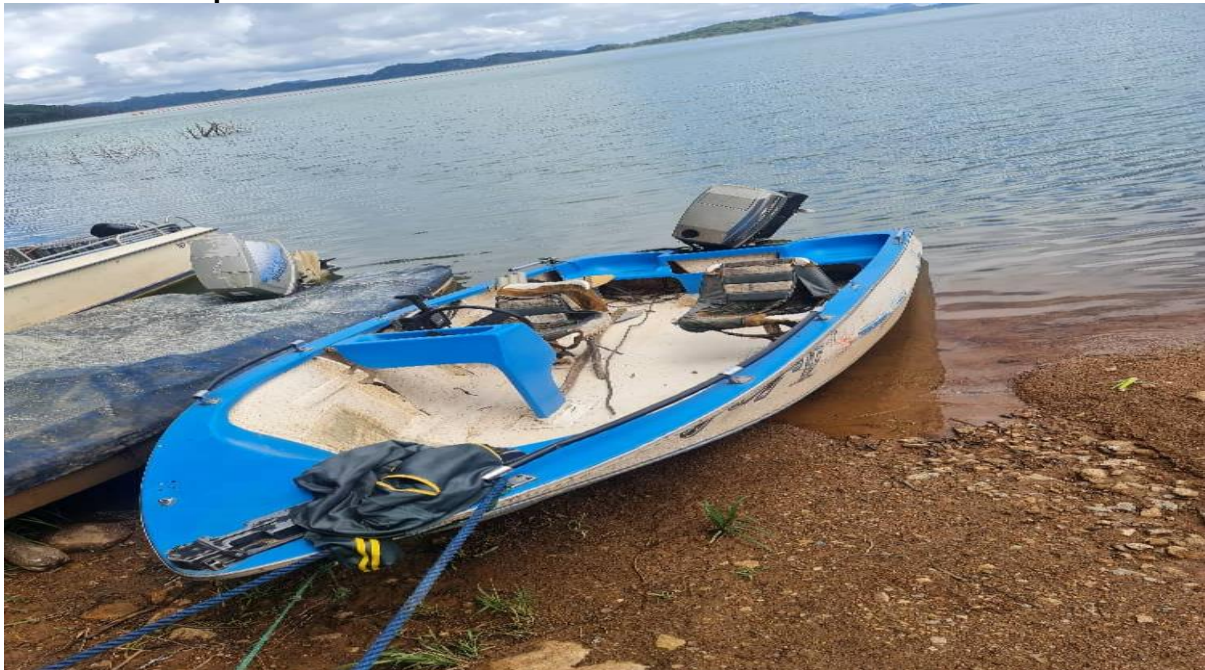
Picture D: Sampled Harbour at the dam.

The Anchor required site establishment and coming up with site plan design of the control tower, Construction of Robertson house for staff accommodation and office building and establishment of harbours in the short term. A review of the Tugwi-Mukosi consolidated report of July 2021 showed that tenders for the construction of the Control Tower and two (2) harbours were flighted in the newspapers. It was also revealed that ZWL\$150 million had been allocated under the 2021 budget and the siting of the control tower was established. There was no evidence availed to audit on the site plan designs and plans for construction of the Robertson house and office building. From inspections conducted on the dam, audit observed that neither construction of the Navigation Mast, Robertson house and office building nor the Harbour had commenced due to absence of Master Plan. **Picture D** shows undesignated sites currently being used as harbour by existing fishing companies.

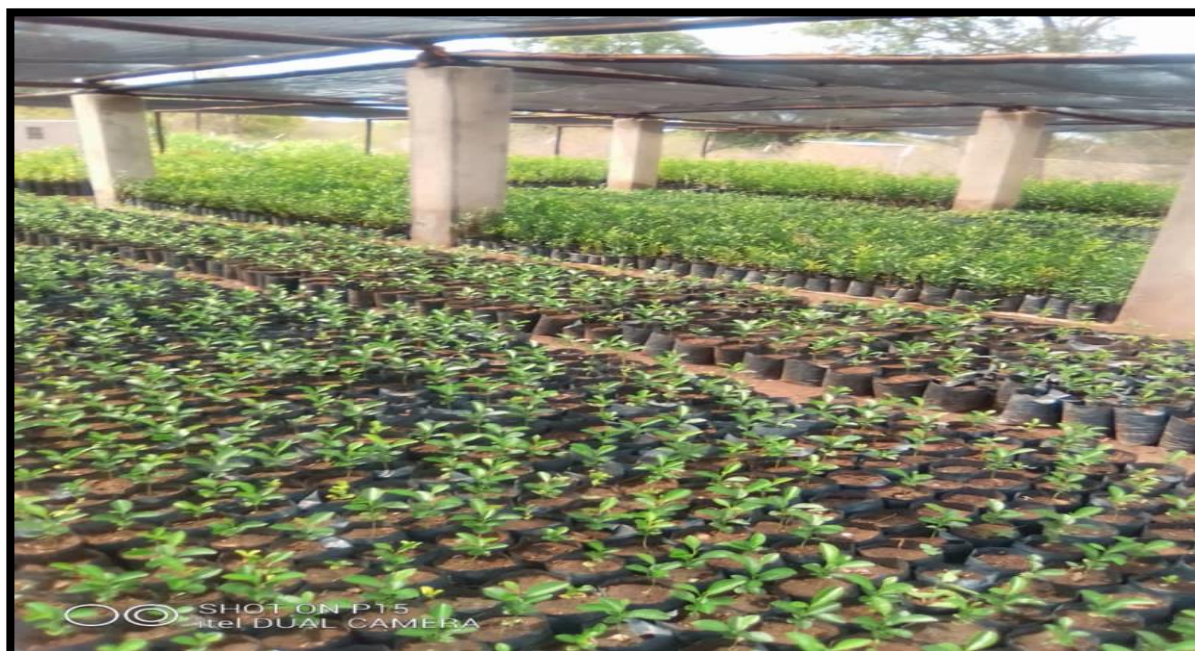
Picture E: Nursery at Bhuka Business Centre- ZICOPE Trust Nursery.

According to interviews, progress update reports and inspections conducted, audit noted that the Forestry Commission had come up with a number of nursery projects in partnership with communities. Amongst these projects was a nursery project owned by ZICOPE Trust at Bhuka Business Centre with approximately 15 000 assorted seedlings and Mpofu Nursery with 1 000 seedlings in Masvingo District. Apart from this Muzogwe Nursery in Chivi District had approximately 5 000 seedlings. **Picture E** below shows part of the ZICOPE Trust Nursery at Bhuka Business Centre taken during my audit inspections. Interviews with Forestry Commission official revealed that although some of the plants were being sold to willing buyers, the majority of the plants were being donated to the beneficiaries including communities, schools and clinics. Audit observed that as a result of the low uptake by Forestry Commission in its programmes, schools and clinics, most plants in the nursery had wilted and matured to the extent of bearing fruits.

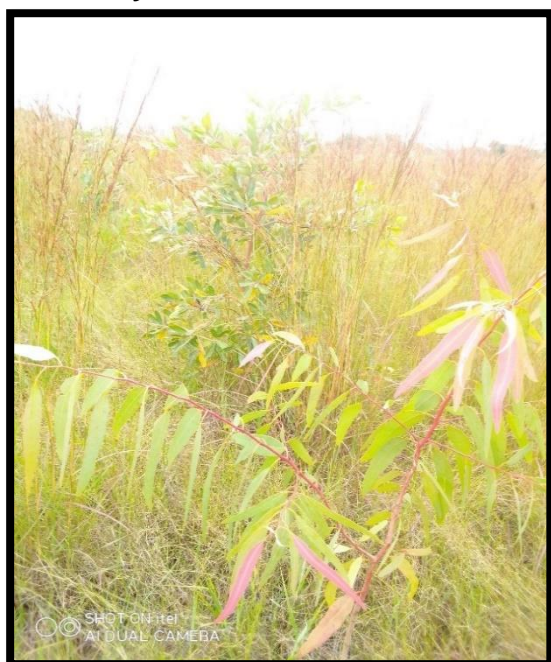
Picture F: Gum Plantation-Gunikuni Secondary School in Chivi.

survival of planted seeds. Audit noted that there were no fire guards where the plants were planted to safeguard them from fire hazards. Also Forestry Commission did not monitor whether the plants were being given proper care to increase the chances of survival. The Forestry Commission officials indicated that they were not carrying out monitoring and inspection activities as they have only one vehicle (Mazda B2200) which was old and obsolete.

Picture F shows the state of the plants at Gunikuni Secondary School. Audit also visited Chindiro homestead in Chivi District to assess on the plants that had been planted. The plants included fruit and indigenous trees. According to interviews with family members at the homestead the survival rate of the plants was well below 50%. Hot and dry weather conditions in the area, were again cited as major reasons for poor survival of planted seeds. Refer to **Picture G**.

The survival rate of trees planted is not good in some areas due to harsh weather conditions experienced within the catchment. Forestry Commission plans to intensify ownership of the project by responsible authorities, especially on schools to enhance sustainability.

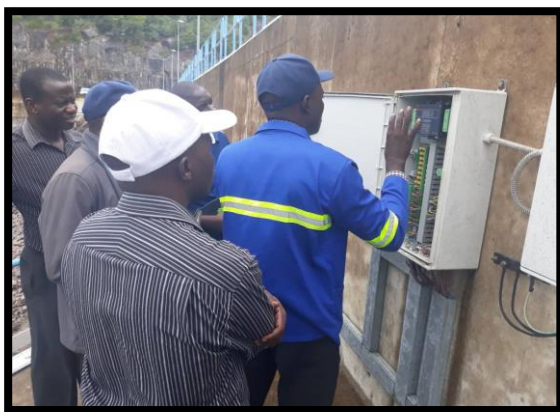
Picture H: Electronic devices.

However, the Tugwi Mukosi Dam wall had a computerised system to monitor the behaviour of the dam structure, slope/abutment movement and water pressure induced movements within the structure among others. The dam instrumentation that was the sensors and other electrical gadgets assisted the engineers to monitor the cracks and any unusual movement of the dam wall for them to take corrective measures. During inspection of the Dam, the Water Bailiff and Security Officer took auditors through the computerised dam safety monitoring instruments that were embedded on the wall. The installed machines send signals to the data loggers and then to the server. Refer to **Pictures H and I** reflecting the computerised system. However, at the time of audit on March 14, 2023, the server was not working since September 2022 as the data loggers were not transmitting data to the server. Also there was a challenge of software that had expired which needed upgrading and the Ministry could not raise the foreign currency needed in time as per contract agreement. The software to upgrade the system was not locally available and need engagement of the contractor who installed.

The inactiveness of the system may pose a threat to the safety of the Dam though the engineers resort to using the manual system to assess the safety of the structure. Cracks or fissures that threaten the sustainability of the structure may develop unnoticed.

- Ensure that the available computerised system to monitor the behaviour of the dam structure is always working to detect any changes. Also institute a monitoring mechanism for cracks that develop on the dam walls in line with international dam safety requirements. There is a risk that if the wall fails, many lives and property may be lost as there may be flooding downstream

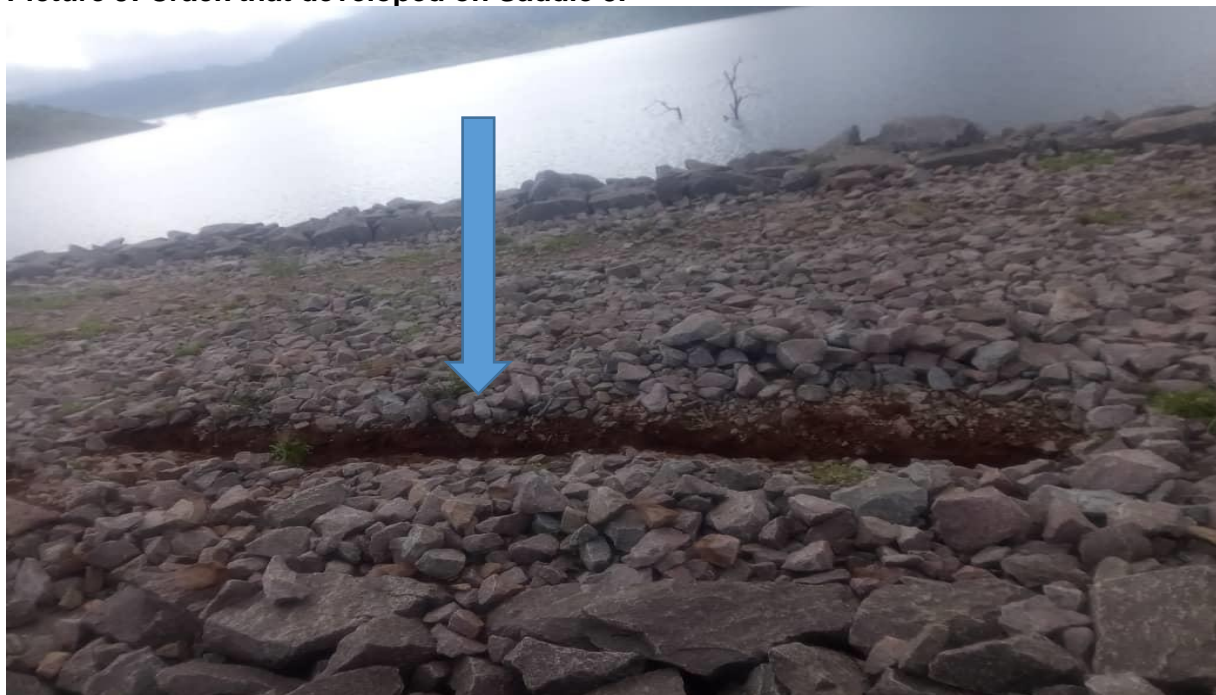
Picture J: Crack that developed on Saddle 3.

- Saddle Dam 3 at Tugwi Mukosi Dam had developed a deep crack at the time of audit in March 2023. Also, there were no devices placed on the crack to monitor the severity and whether it was further enlarging with time. There was a great risk that if the wall fails, many lives and property may be lost due to flooding downstream.

During my inspections at the time of audit in March 2023, I discovered that a deep crack was developing along Saddle 3. Refer to **Picture J**. Interviews with Runde Catchment Council officials indicated that the crack posed no threat to the sustainability of the dam. In compliance with the International Commission on Large Dams requirements on dam safety, there were no devices placed on the crack to monitor whether it is enlarging with time. There is a risk that if the wall fails, many lives and property may be lost due to flooding downstream. ZINWA Officials indicated that the crack needed an independent assessment to establish the impact of it on the structure. However, ZINWA had not yet established an Independent Regulator of Dam Safety to carry out independent dam safety assessments at the time of audit in March 2023.

From ZINWA's internal inspections, the crack is not a threat to the integrity of the Dam. The crack is being monitored every season. The Ministry of Lands, Agriculture, Fisheries, Water and Rural Development is working on the establishment of a Water Sector Regulator with dam safety component.

- Institute a monitoring mechanism for cracks that develop on the dam walls in line with international dam safety requirements. There is a risk that if the wall fails, many lives and property may be lost as there may be flooding downstream.

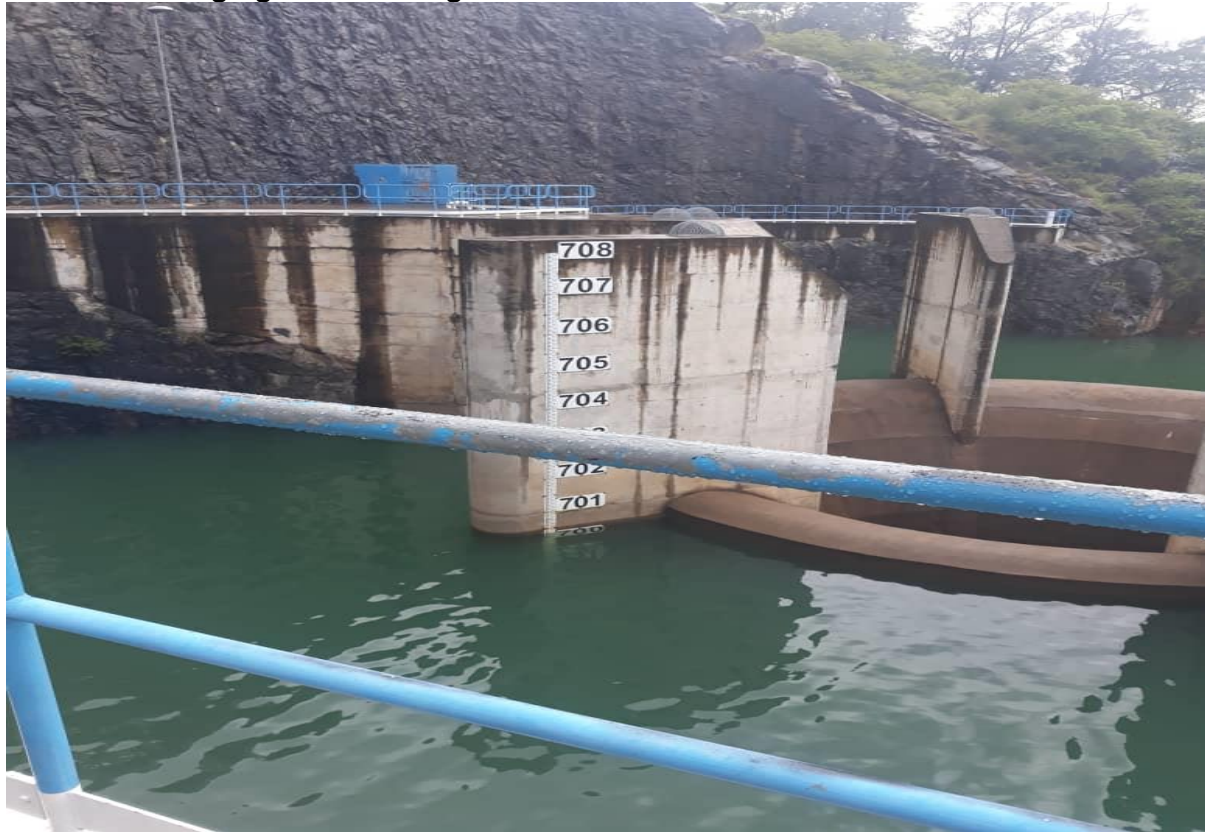
Picture K: Gauging Plates at Tugwi Mukosi Dam.

The Dam had gauging plates on the wall which they used to monitor the volumes of the water in the dam. However, the gauging plates only measured volumes from 698m to 708m above sea level. In case the dam volumes subside to volumes beyond that, there are no plates to gauge the volumes to determine the yield of the dam. **Picture K** shows gauging plates at the Tugwi Mukosi Dam wall.

Absence of gauging station to provide on time hydrological data may result in ill preparedness by ZINWA against the risk of flooding in the upper and downstream of the river. If water is released without control there is risk that people downstream and animals will be killed, the wall may also be damaged by uncontrolled flood.

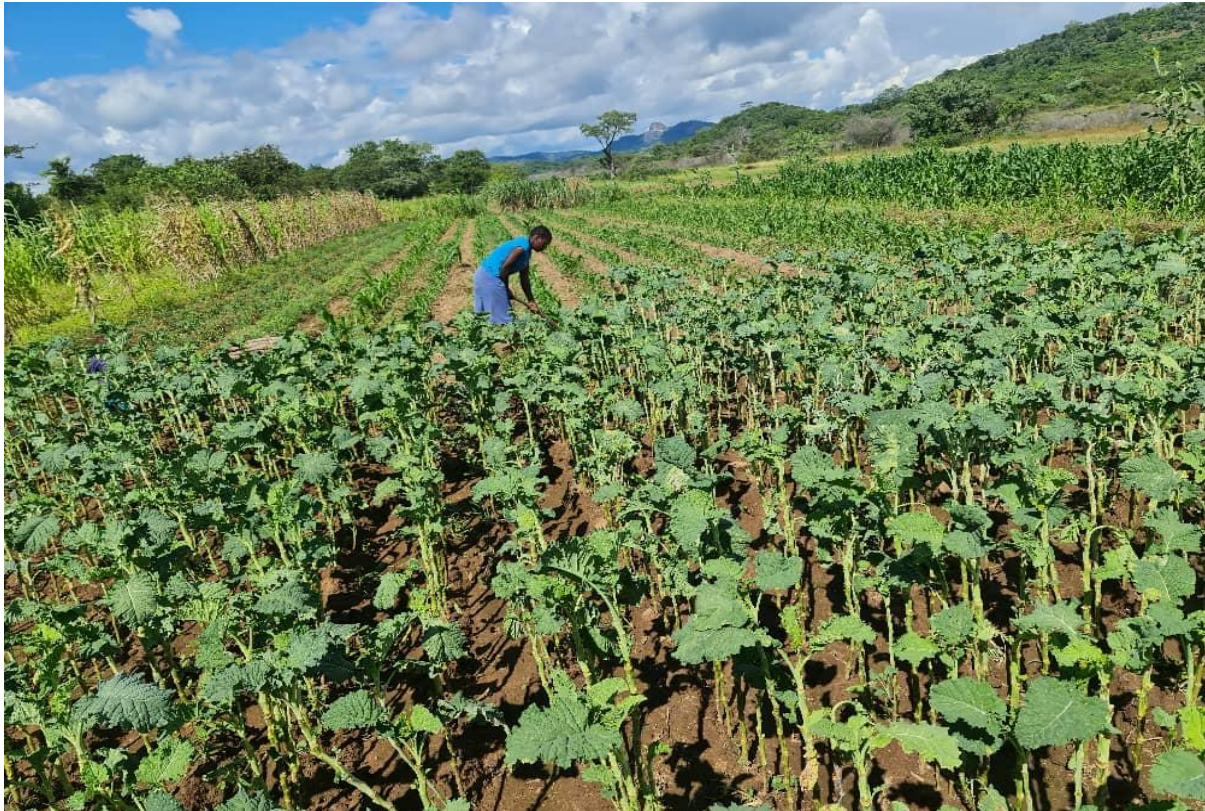
Picture L: Garden in the basin.

I noted that the dam was prone to high rate of siltation due to excessive farming activities, overstocking and deforestation by the residents. The market gardens on the basin of the dam by illegal settlers may also contribute to the siltation of the dam. Audit witnessed gardens in Ward 24 which were less than 100m from the dam thereby posing a risk of siltation of the water body in the short to long term period. Refer to **Picture L** for a market garden within the dam basin. Cultivation of crops on the banks of the tributaries that feed the dam was rampant, for instance, Vahondo River in Masvingo Ward 24 (Museva area). These activities exposed the land to erosion which lead to gully formation in some areas in Chivi and Masvingo Rural Districts.

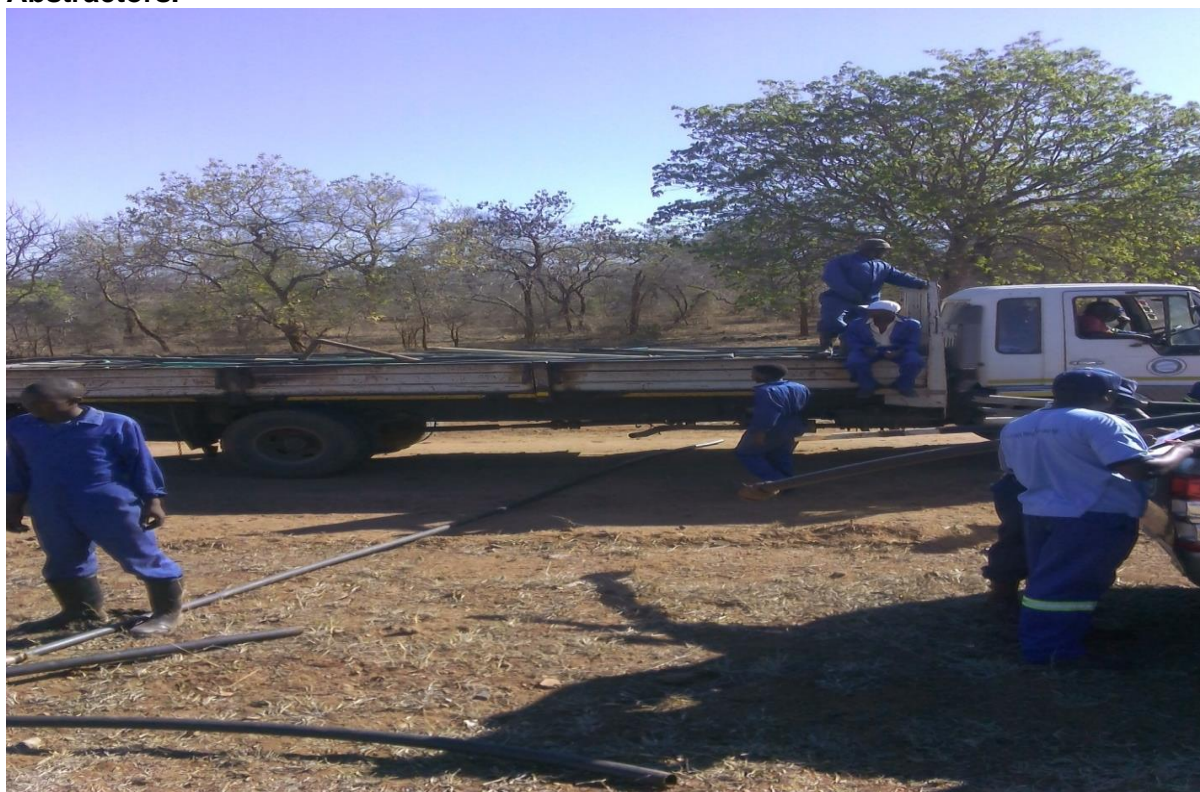
Picture M: Man at Work Loading Recovered Pipes in a Lorry used by Illegal Abstractors.

However, in trying to avert the problem of illegal abstractions, the security team periodically carried out some blitz operations, confiscating engines and pipes along the canals. Refer to **Picture M**. In spite of that, the illegal abstractors continued to replace the engines and pipes. Interviews with ZINWA Officials indicated that there was poor coordination between Department of Lands, Zimbabwe Republic Police and Local Authorities in fighting illegal abstractions along the canals. There were supposed to carry out regular awareness campaigns and blitz operations together.

Security along canal system needs to be enhanced to regularly monitor the same as a way of curbing illegal abstractions of water. There was no vehicle for the security personnel at the Tugwi -Mukosi dam at the time of audit, March 13, 2023. The availability of a vehicle would have increased the mobility of the security officers thereby reducing incidences of illegal water abstractions.
